# Manhole Inspection Summary

Manhole # S29Q\_\_030MH

**Location** Address: **109 West Ostend St**

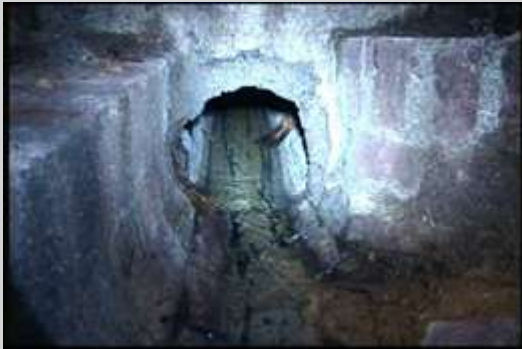
12 O'Clock Outflow

8 in. Circular Gravity Sewer  
Pipe Out @ 12 O'Clock

Pipe Height: **8.4** (in.) Rod and Bar (Angled)  
Pipe Material: **Clay** ☐ Pipe Lined  
Invert Depth: **11.95** (ft.) Flow Characteristics: **Slow**  
Deposits: ☒ None ☐ Mud ☐ Gravy ☐ Debris ☐ Grease  
Silt Depth: **0** (in.) Deposits Extent:  
Infiltration: **None** Pipe Seal Cond: **Sound**
